Concrete Coalition Phase II: Concrete Building Performance Record

2-story classroom building prior to January 12, 2010 earthquake.

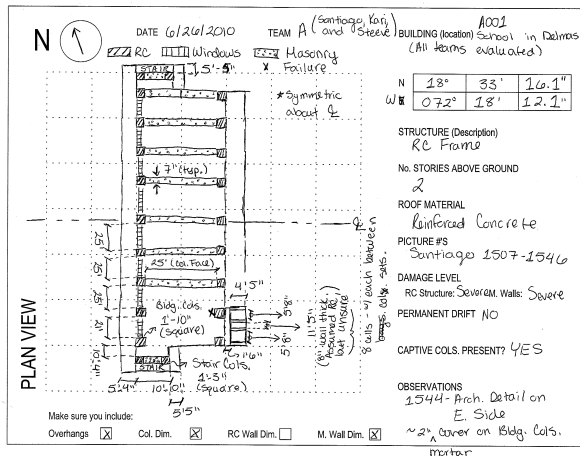
Sketch of building plan. (NEEShub, 2010)

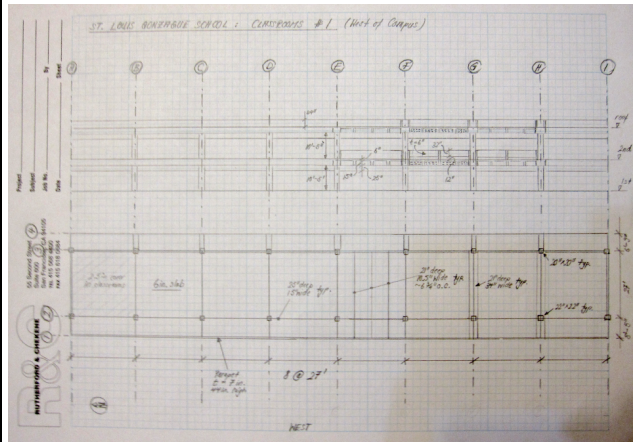
Sketch of building plan and elevation.
(Schellenberg, 2010)

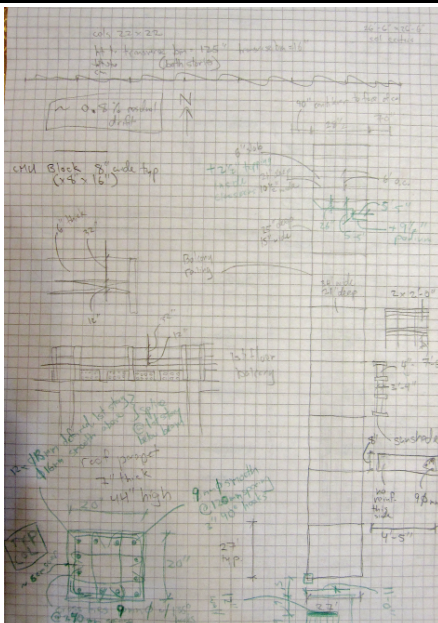
Supplemental building information as observed in field. (Telleen, 2010)

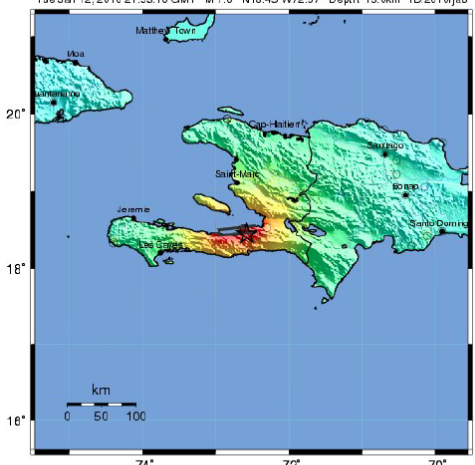
<div><p>USGS ShakeMap : HAITI REGION Tue Jan 12, 2010 21:53:10 GMT M 7.0 N18.45 W72.57 Depth 13.0km ID:2010rja6</p>

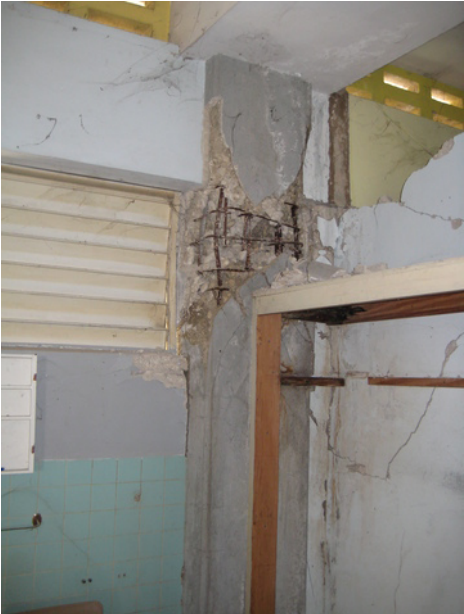
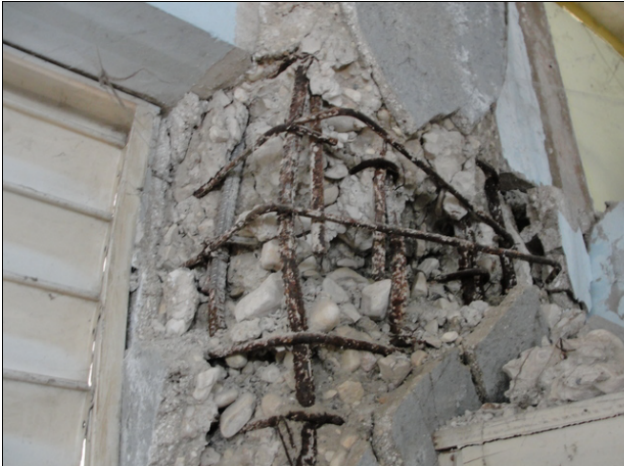
<p>Shear damage in first-story column due to captive column condition. (NEEShub, 2010)</p>	<p>Close-up of shear damage in first-story column. (NEEShub, 2010)</p>

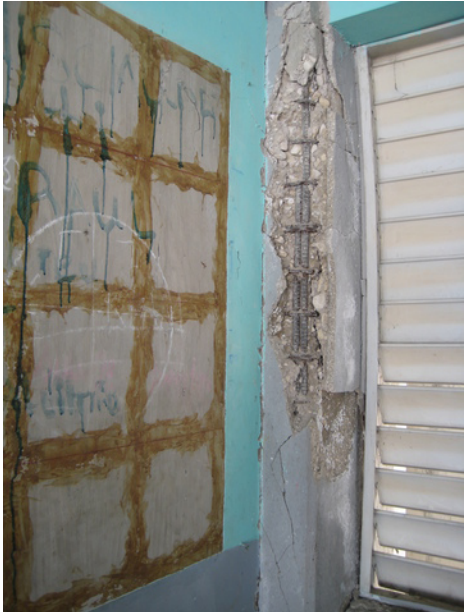
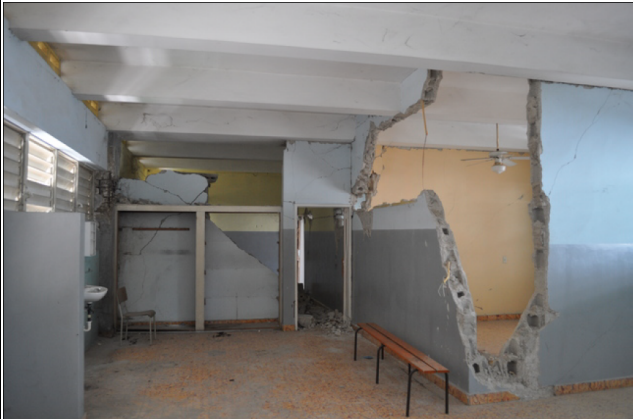
<p>Extensive spalling of first-story column. (NEEShub, 2010)</p>	<p>Severe damage to nonstructural URM walls. (NEEShub, 2010)</p>
