# City of Berkeley Concrete Building Inventory Validation Project

A report prepared by the Earthquake Engineering Research Institute

January 2018

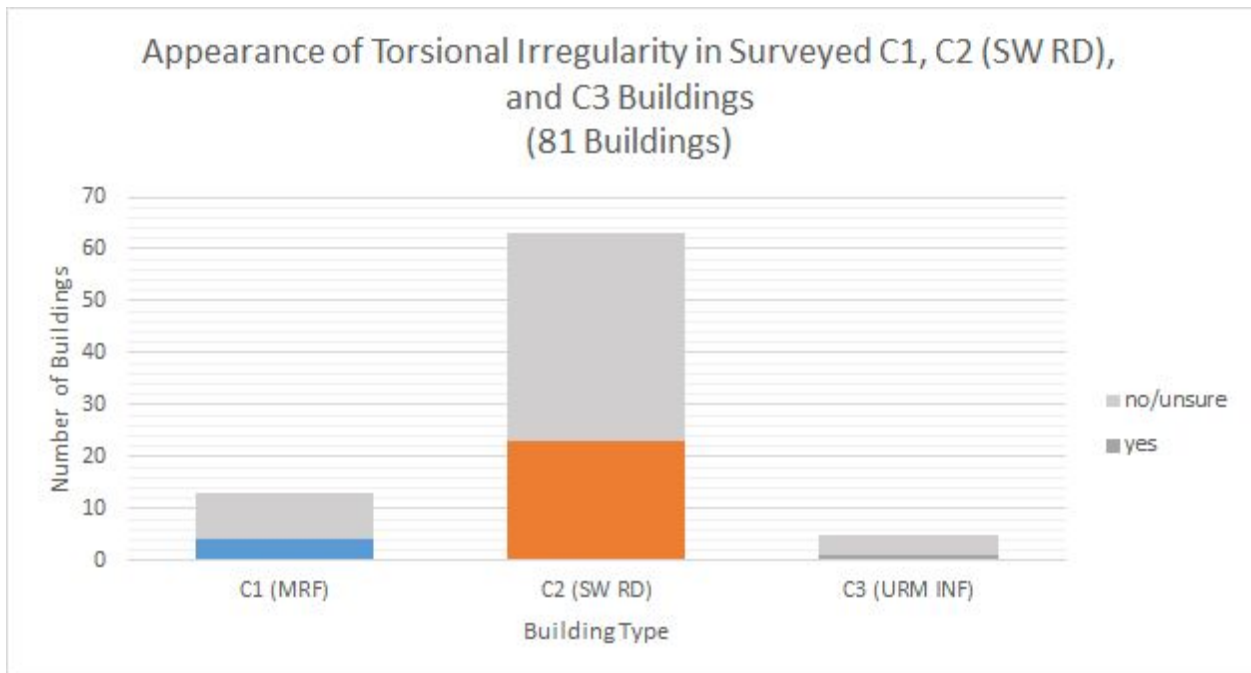
Figure 16.

One question about the presence of a torsional irregularity was included in the survey. Of the 81 C1, C2 (SW RD), and C3 buildings surveyed, 28 were identified by engineers as having a torsional irregularity. Of these 28 buildings, four are C1, 23 are C2 (SW RD), and one is C3. Two of these 28 buildings showed signs of seismic retrofit. Figure 16 shows the relevant surveyed buildings with the appearance of a torsional irregularity broken down by building type. Figure 16 does not include RWFD buildings types as there may have been inconsistencies in how survey engineers responded to the torsional irregularity question in the survey for RWFD buildings.
